PRELIMINARY ASSESSMENT

BAKER BEAN AND FEED

POWELL, PARK COUNTY, WYOMING

TDD #F08-9106-15 - PAN #FWY0093PAA

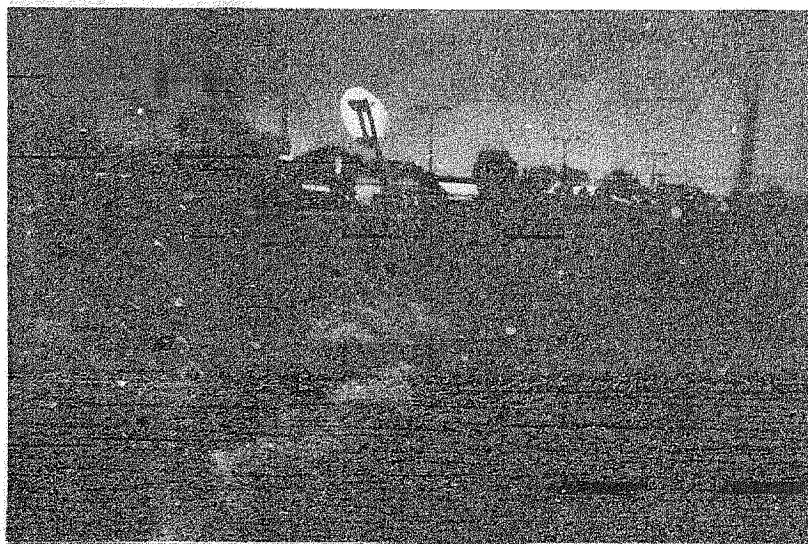
Runoff water from the fire was contained and removed. Currently, there are soil stains and a damaged culvert in the area of containment (Photos 14 and 15). The stains could be attributed to any number of sources, given the large amounts of commercial/agricultural activity in the area. FIT staff conducting the site visit felt that it could have been used oil or some other wetting agent applied to stabilize the canal embankment. The soil surrounding the fire site was staged in drums and removed from the site. Confirmation clean-up samples show no dangerous

PHOTO 15: DAMAGED CULVERT DRAIN, NEAR STAINED SOIL FACING EAST.
